RESOLUTION FY 2014-10

Adoption of Facility Master Plan

Edison Community College Facility Master Plan

For Presentation to the Edison Community College Board of Trustees October, 2013 Prepared by Doug Riehle, Director of Physical Plant and Facilities

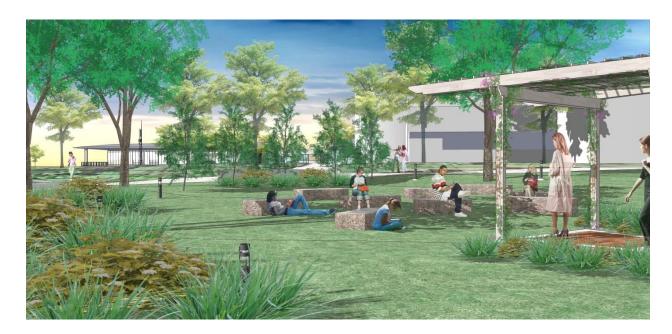
Artist's concept of Outdoor Classroom

One of the major outdoor upgrades planned for the near future will be the addition of an outdoor classroom. The will be an inviting, partially shaded area in the southwest section of the campus near West Hall. There will be a covered podium for teaching, granite benches for seating, and attractive landscaping. The Outdoor Classroom is also an area that will honor Edison's retirees with names etched in pavers as a focal point in the landscaping. The cost is estimated at approximately \$100,000. The College is currently working on securing funding the project for possible implementation in 2014 or 2015.

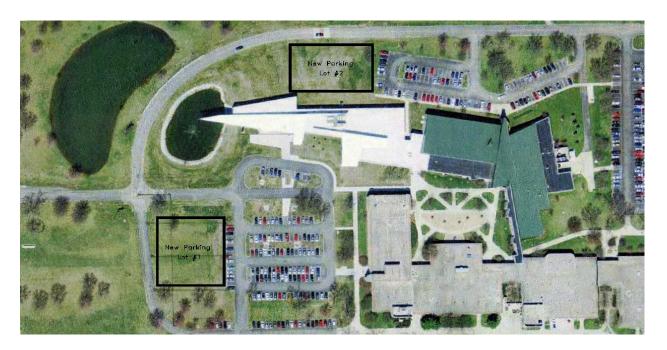
Layout of Expanded Parking Lots

The first location for additional parking is an area just West of Lot #2. There is adequate space to add 63 parking spots in this location. The reason this is considered the best location is that it is relatively close to both West Hall and Emerson and therefore would be used by students going to either location.

The second location for future parking expansion is north of the Emerson Center and west of current Lot #3. This lot would improve parking for the Library, Learning Center, and the 500 series classrooms in Emerson, and would also be convenient to North Hall for access to Nursing, the gym, and Theater. The Nursing students would likely park in this lot due to its convenience to the Nursing classrooms. This would free up space in current Lot #2 for students going to West Hall. There is space for 61 additional parking spots in this location.

The completion of these two new parking lots will add a total of 124 new spaces in prime locations to provide easy access to classrooms and the library. The additional parking spots will also increase the College's parking capacity to support a total FTE enrollment of 4476 from the current capacity of 4063.

Initial plans have been developed and \$300,000 capital funds of have been appropriated by the state legislature to expand these two parking lots. The college has hired an architect and plans have been completed for the expansion. The project is currently out for bids, with construction to start in the spring of 2014 and completed before the 2014 fall semester.

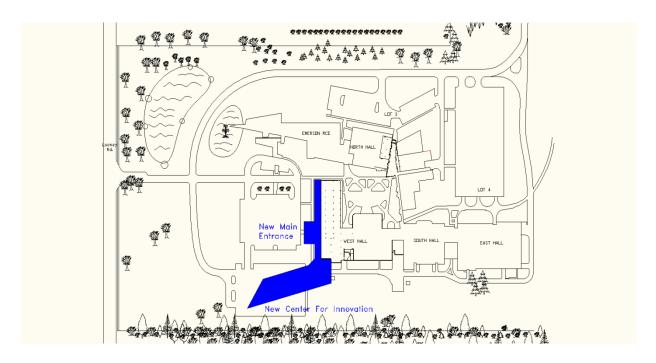
New Main Entrance & Center for Innovation

These needs are addressed by the proposed construction of a new main entrance and a new wing called the "Center for Innovation" that would be built west and southwest of the existing West Hall main entrance (see the campus map below).

The new construction will include a clearly defined main entrance visible from the main driveway. The entrance would lead to an attractive new lobby and information desk that will flow directly into Student Affairs and other student support areas.
